STS-100 FLIGHT READINESS REVIEW

April 5, 2001

Ground Operations

STS-100 / OV-105 Operations Summary

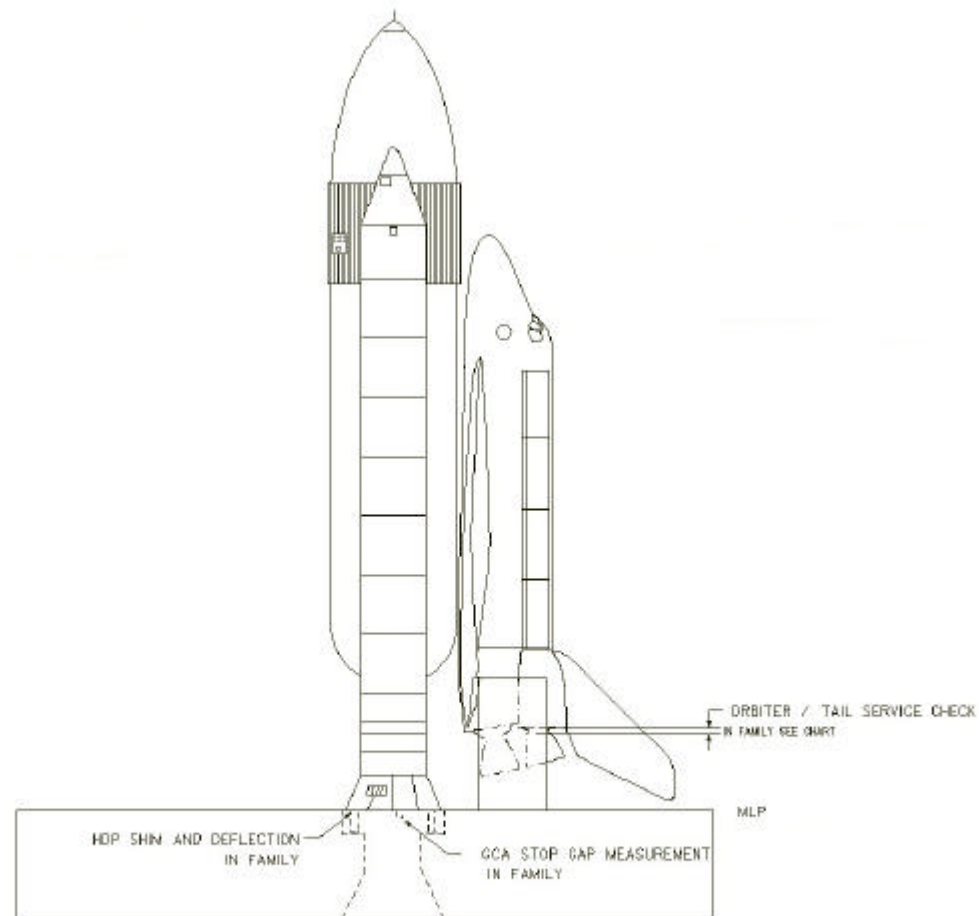
STS-100 TSM / ORBITER CHECK

- Discussion
 - 1st time combination of MLP1, Pad-A, Lightweight ET, and OV-105 with no payload (Shuttle light)
 - Clearance of PLB door to PCR seal always minimal
 - Optics revealed PCR 0.4" low (relative to drawing)
 - TSM to orbiter aft optical measurements
 - STS-100 within historical database
 - Orbiter 0.35 inches high (high side of in-family)
 - All other Pad to orbiter umbilical mates nominal
 - No recent mods to Orbiter PLB doors, PCR, or MLP
- Actions Taken
 - Fault Tree analysis performed
 - No vehicle concern based on TSM data
 - PCR structural inspections performed with no anomalies noted
